"CASH SPECIAL"

"SHORT
CASH SPECIAL"
STUNNERS

MAINTENANCE and REPAIR
MANUAL

ACCLES & SHELVOKE LTD

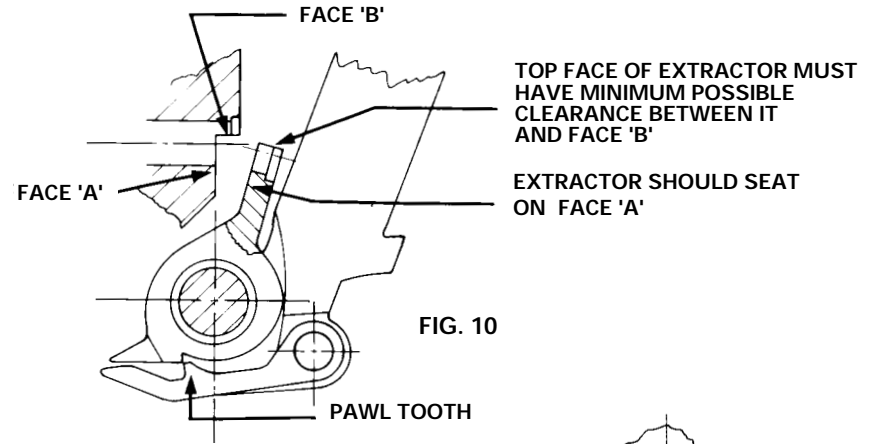
FIG. 10

1. Assemble extractor to Firing Block (710/4), check that tooth of pawl (710/27) fits its working face on the extractor (see Fig. 10). If necessary, file this face on the extractor with a super smooth file to achieve the necessary fit; if possible the tooth of the pawl should be of such a fit that it requires a slight push to engage on its working face on the extractor.

2. The extractor, still assembled to the Firing Block, should be assembled to the Barrel. If the top face of the extractor (see Fig. 10) interferes with the cut out in the breech block it will be necessary to file this face of the extractor so that it just clears to allow the "blade" face of the extractor to seat. It is important that only the minimum amount of material is filed from this top face, with a super smooth file.

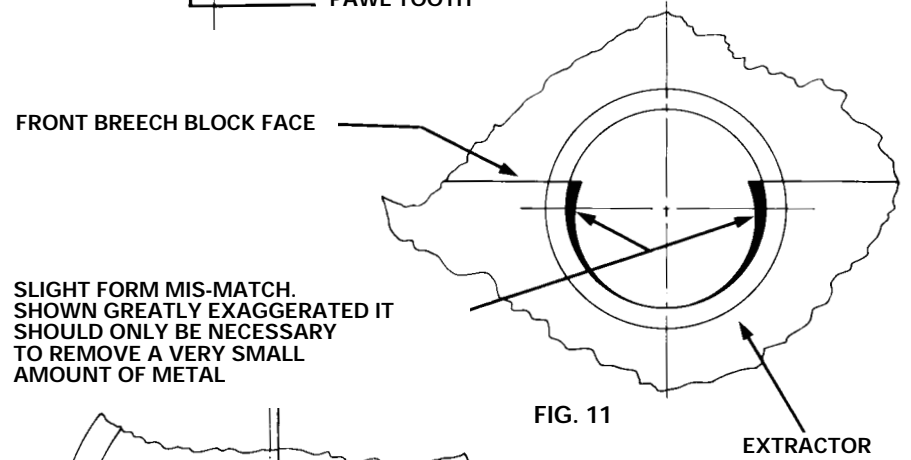
FIG. 11

- (a) If the chamber portion is central to the complete form in the breech block (see Fig. 11) but there is mis-match of the form, then using a super smooth round file, gently remove material until the powerload will insert.

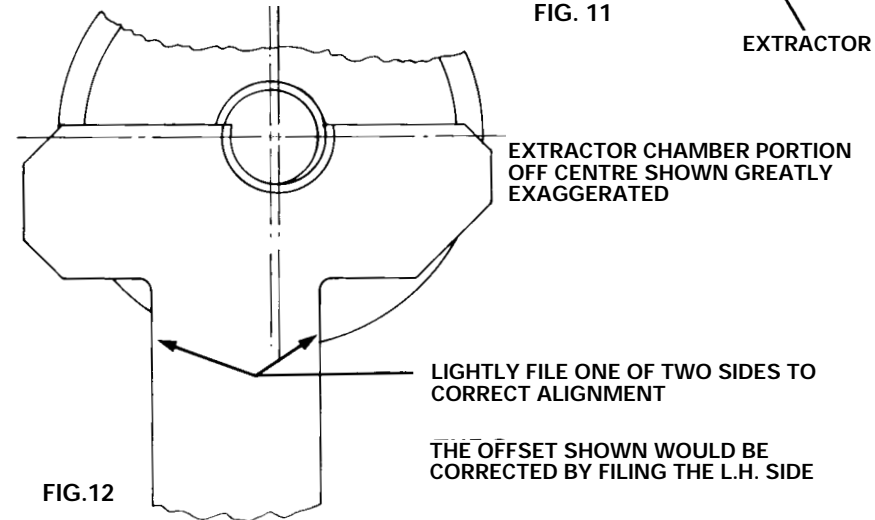
FIG. 12

- (b) If the chamber portion is not central to the complete form of the chamber and breech block (see Fig. 12) even when any side clearance has been taken up by powerload insertion, then lightly file one of the two sides of the extractor boss to correct this alignment.

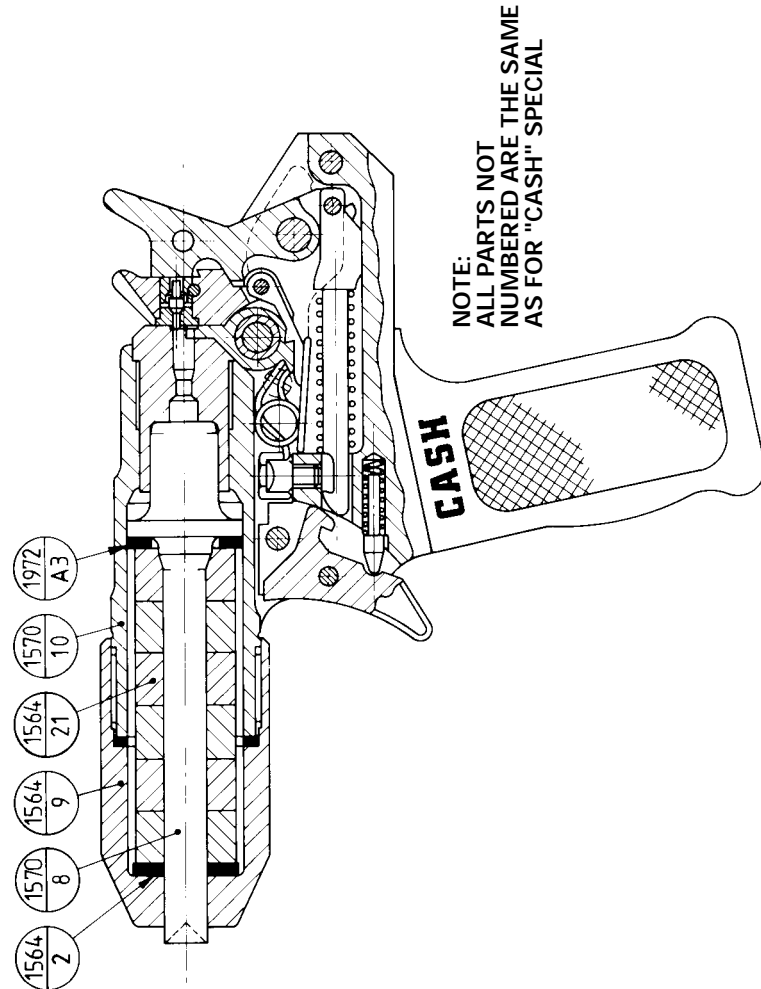
THE "SHORT CASH SPECIAL" CAPTIVE BOLT STUNNER

ALL OTHER PARTS ARE THE SAME AS FOR "CASH SPECIAL"

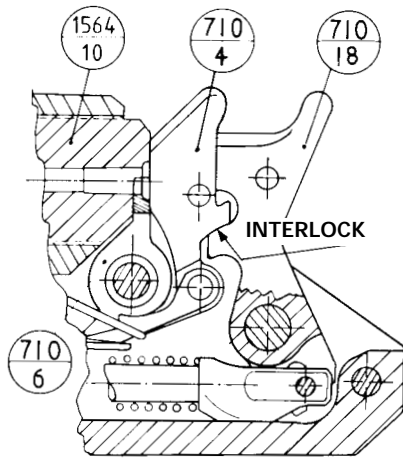
FIG. 5

FITTING PROCEDURE (Fig. 5)

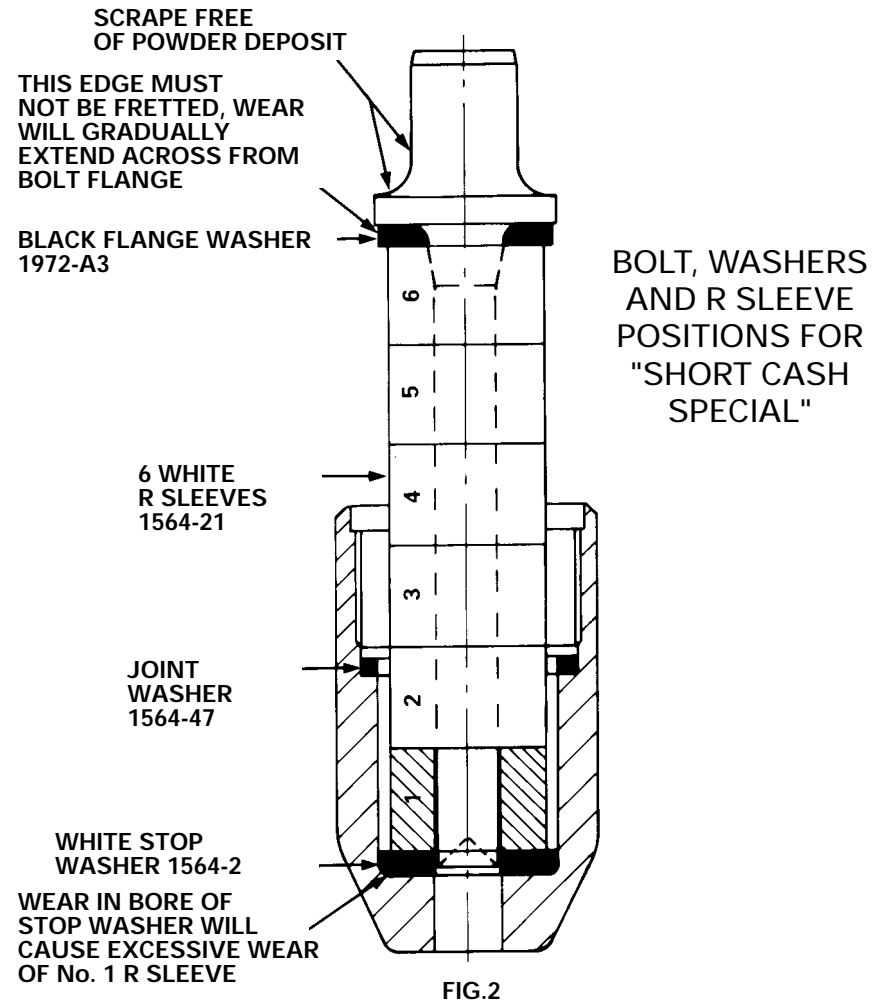
FIG. 2

NOTE: After a few shots with a new set of sleeves they will settle and shorten in length. Expect therefore that with a new set of 6 sleeves the muzzle may be difficult to reassemble to barrel as the sleeves will have to be compressed to engage threads.

NOTE: Providing stop washer is in good condition, the sleeves in position 1, 2 and 3 are less stressed than other positions. To even wear change position of sleeves so that the sleeves which are most worn are in these 1, 2 and 3 positions. If sleeves 4, 5 and 6 are wearing prematurely check that joint washer is in good condition and that the muzzle cap is screwed down to seat on this washer, wear to the outside or the bore of sleeve No. 6 can be caused by a worn flange washer.

8. When re-assembling it is ESSENTIAL that Flange Washer, Recuperator Sleeves and Stop Washer are assembled in their correct positions, exactly as in Fig. 1 OR Fig. 2 for 'Short' model.
Note: The Stop Washer will probably remain firmly in the Muzzle Cap. This is in order.
